**ASSESSMENT OF INSITU, GSS®
GRAFFITI RESISTANT COATINGS
AMERICAN POLYMER CORPORATION**

KTA- Tator, Inc Job No. 230418

JUNE 12, 2003

**Subject: Assessment of Insitu GSS
Graffiti Resistant Coatings**

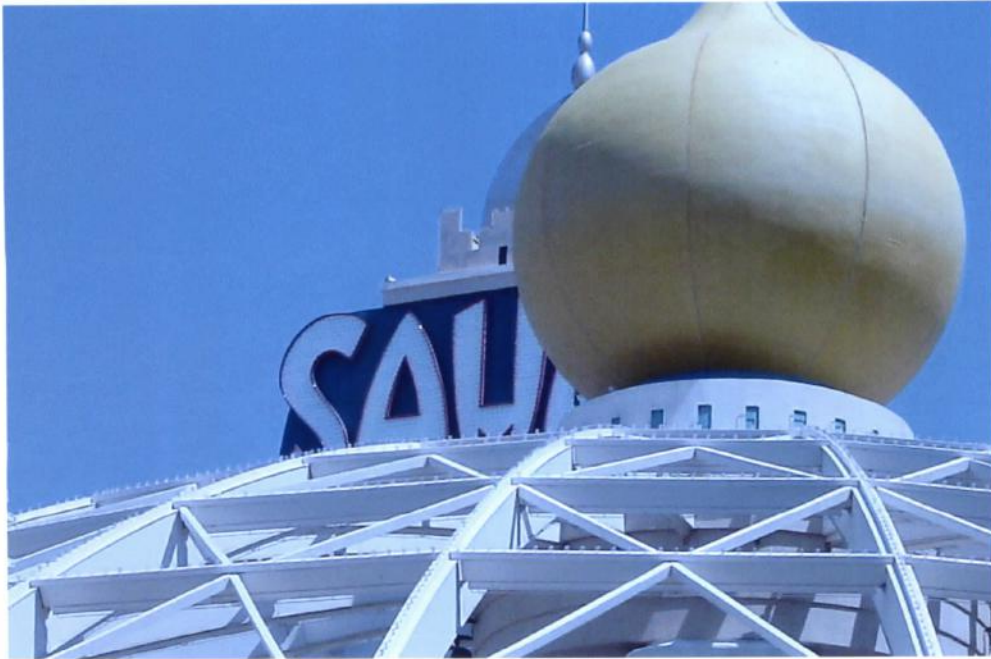
1. Foam-skinned dome at Sahara protected with flat color coat system. Note uniformity of appearance after 6 years of exposure.

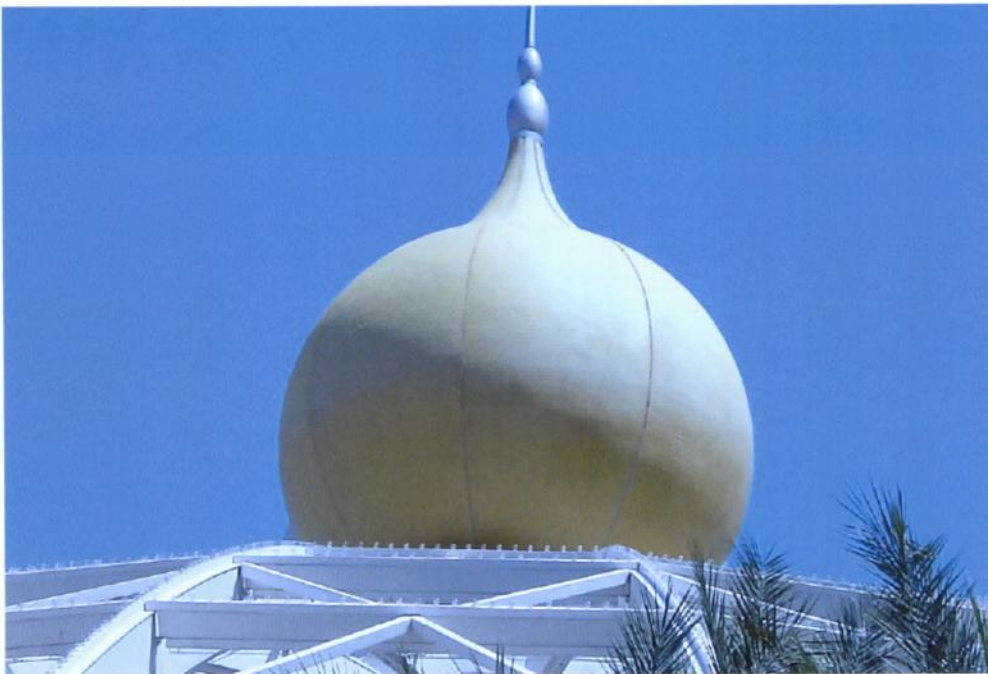
2. Note uniformity of color and gloss with no visible surface defects.

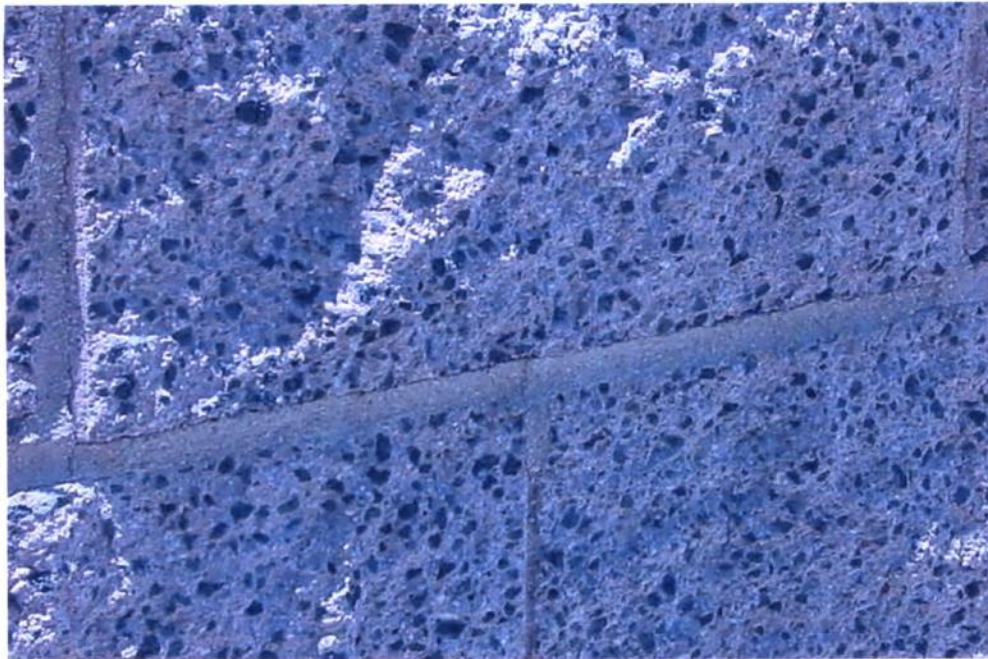
3. Clear GSS system applied to a highly textured block wall at Palo Verde High School. Note the surface is pinhole free yet the texture has not been obscured.

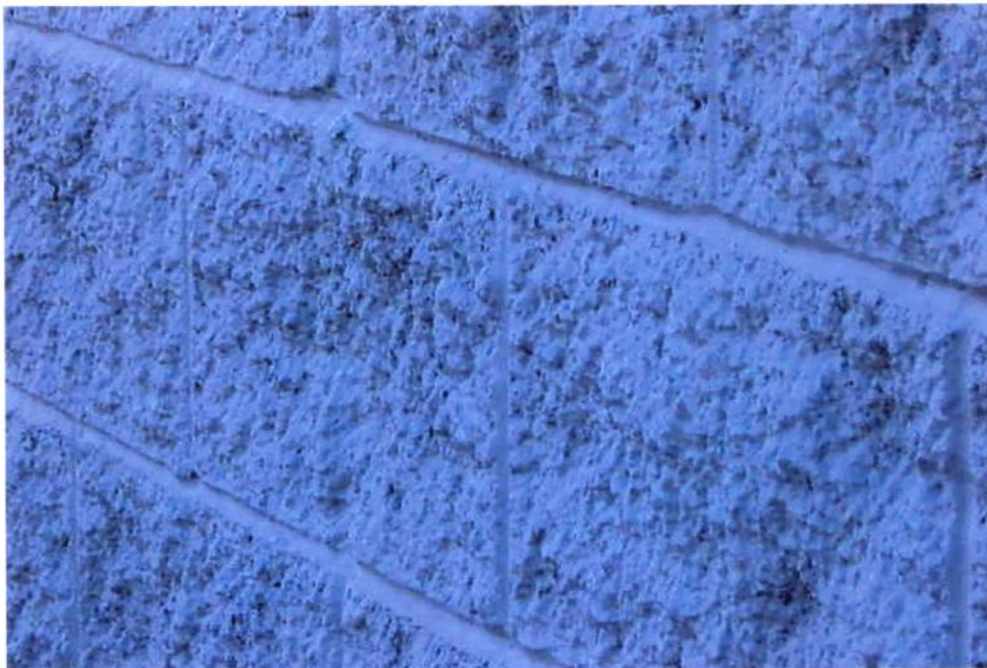
4. A more porous split-face block surface at the Palo Verde High School that has been treated with a base coat system containing a greater amount of filler.

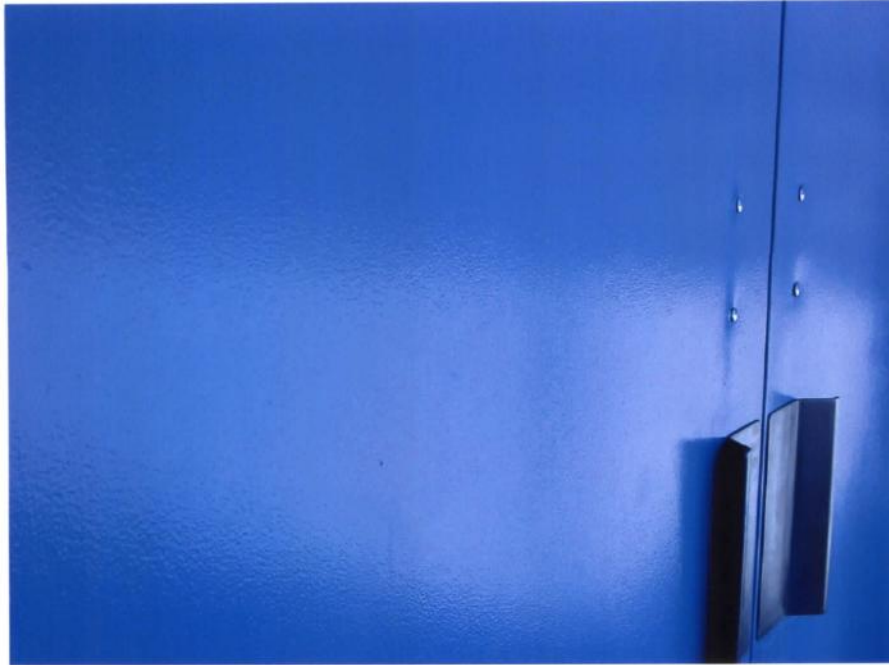
5. Steel faced doors protected with clear GSS-10, Gloss. Note retention of gloss and color after 6 years of exposure.

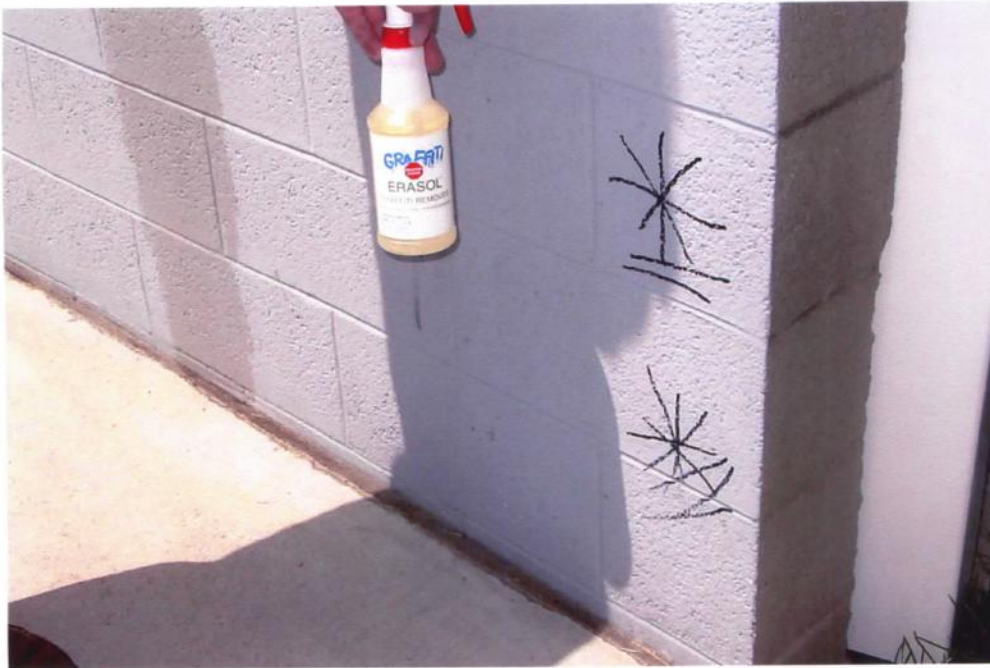
7. Color coated gray, flat GSS system applied to CMU block at the Sandy City Fire Station perimeter wall with black permanent marker type graffiti on the lower blocks.

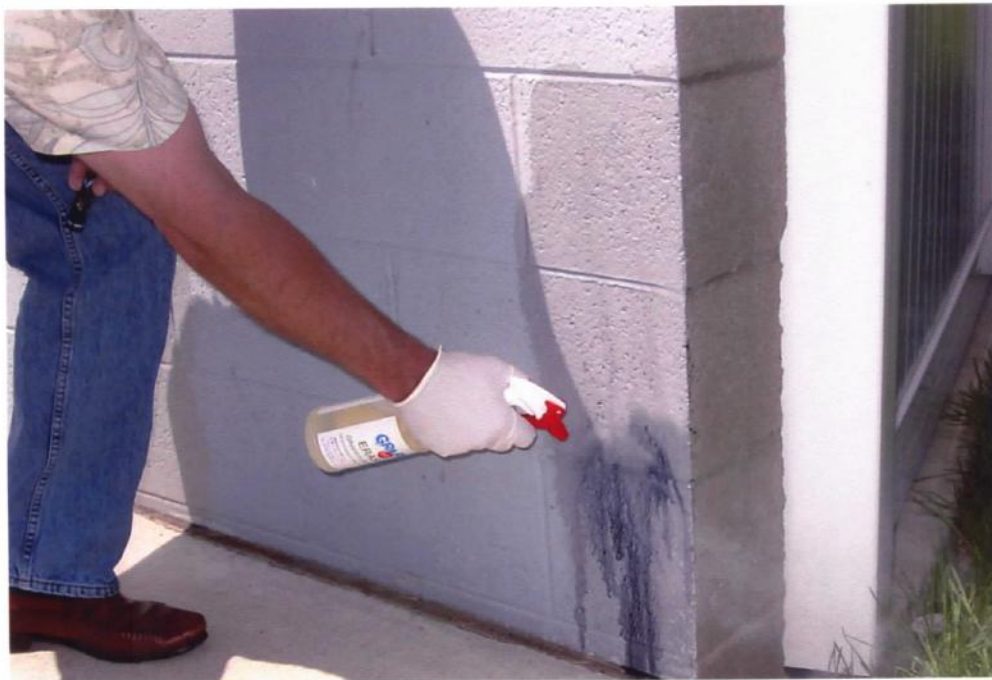
8. View of spray application of Erasol to the graffiti. Note how the graffiti is totally dissolved by the remove.

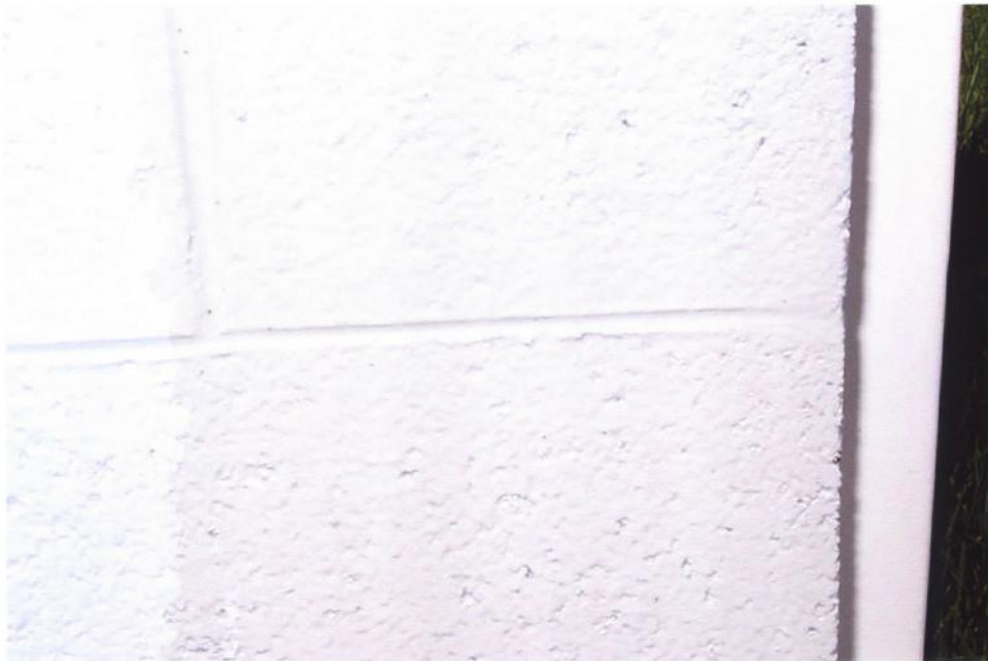
9. Close-up of wall after rinsing the graffiti removed area with water. Note the complete removal of the graffiti with no staining, ghosting or shadowing.

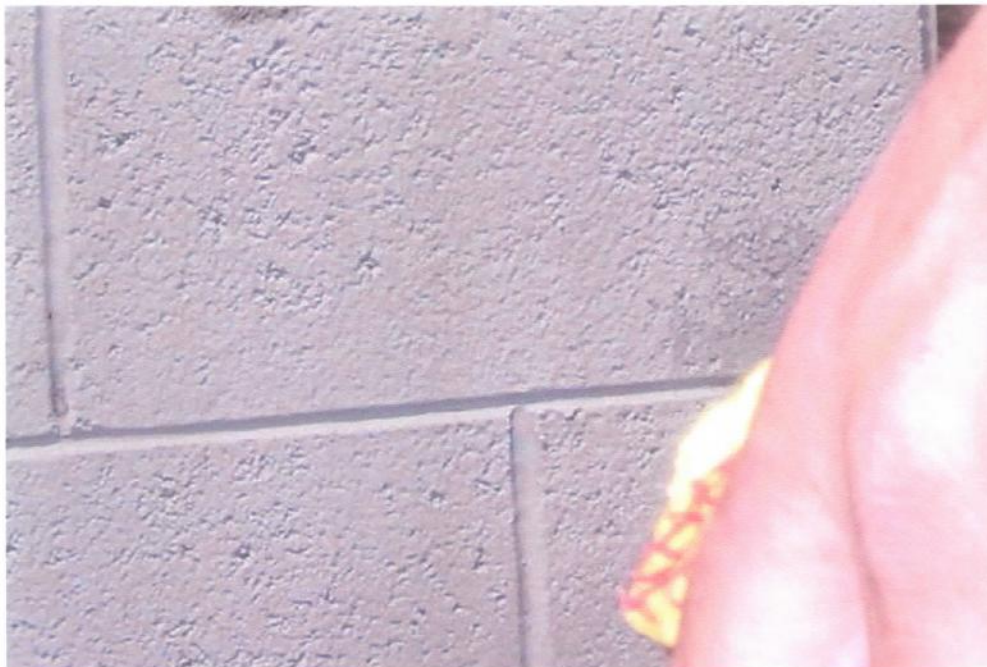
10. Close-up view of wall after drying. Note that the color coat has been virtually unaffected by the Erasol - there is no change in color or gloss when compared to the surrounding areas of wall after graffiti removal.

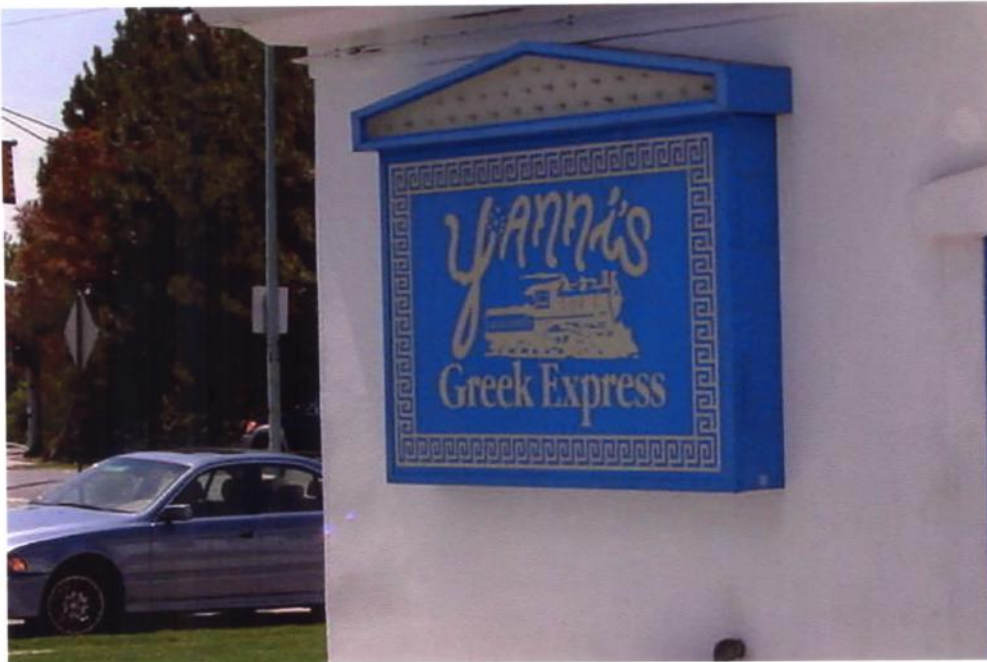
11. Flat, white color coat GSS system applied to sand textured stucco.

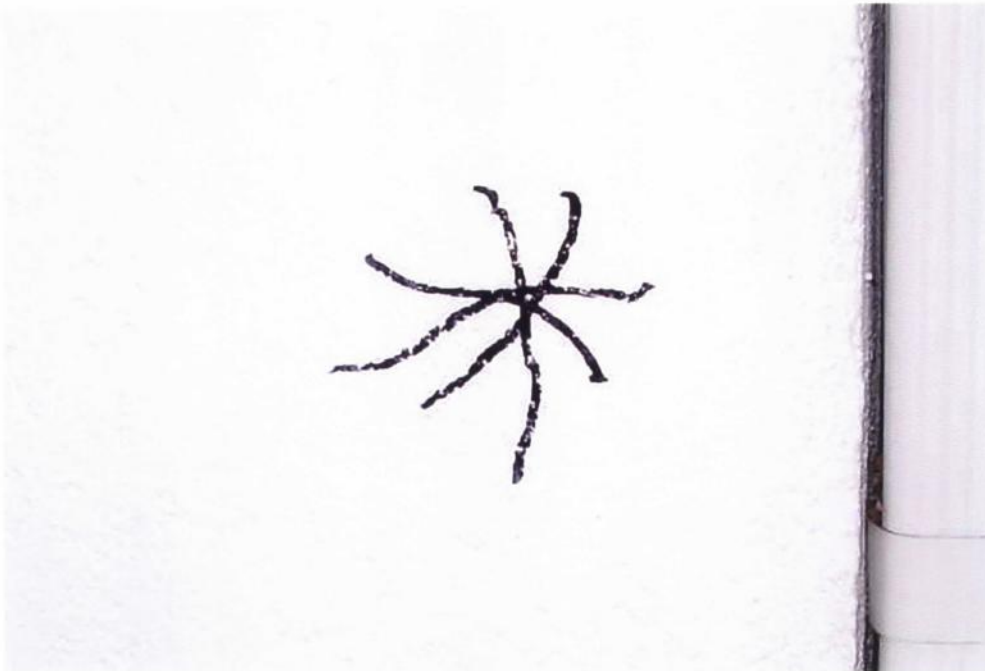
12. Flat, white sand textured stucco wall with black permanent marker type graffiti.

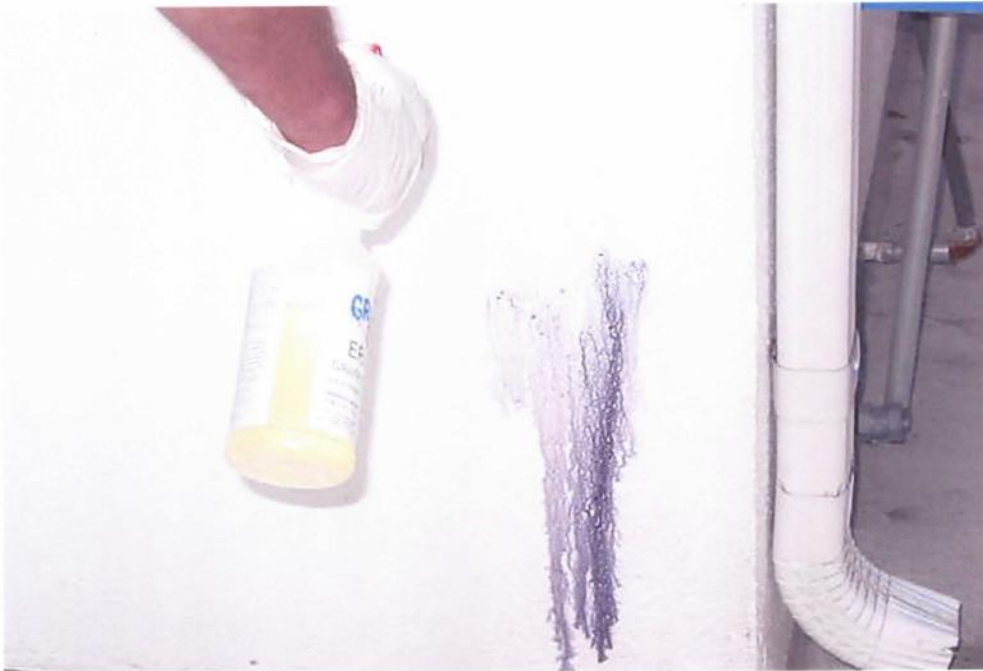
13. View of spray application of Erasol to the graffiti. Note how the graffiti is totally dissolved by the remover.

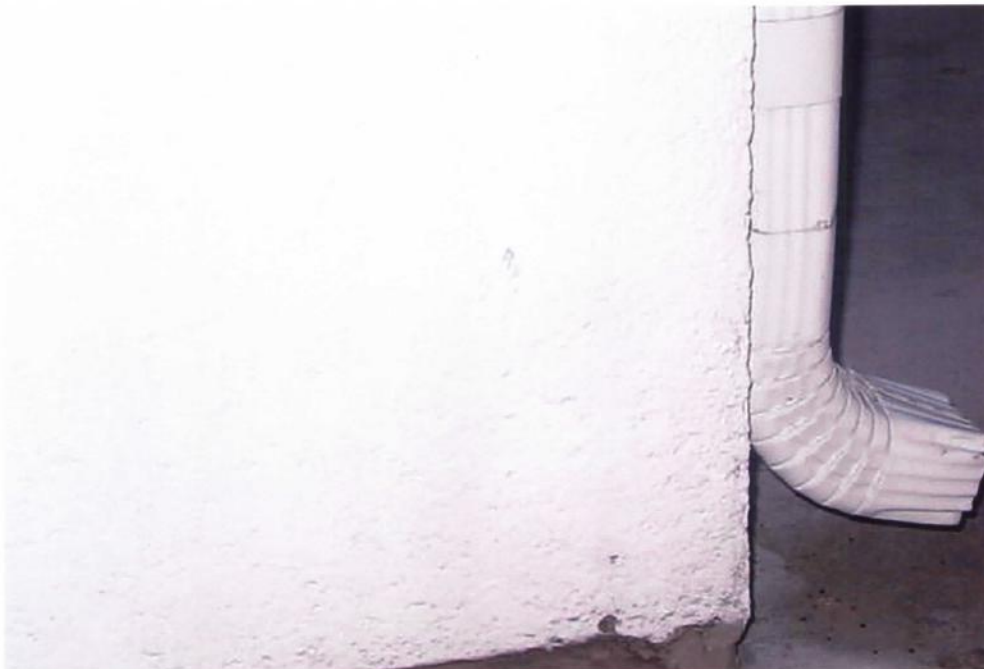
14. View of the stucco wall after removal of graffiti with Erasol. Note the total removal of the black markings with no apparent change to the white color coat.

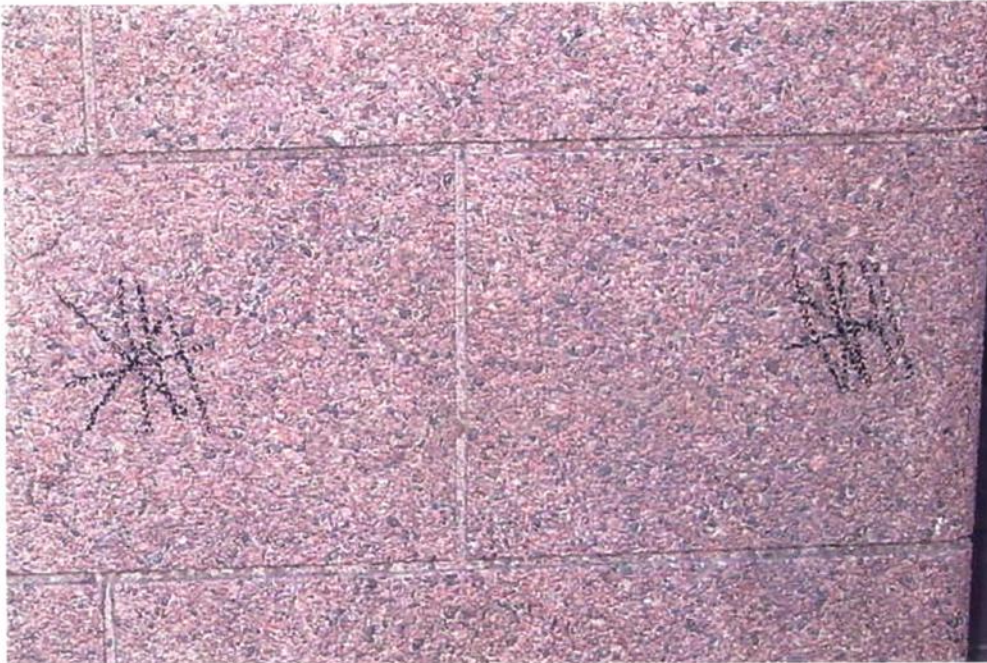
15. Surface with applied graffiti

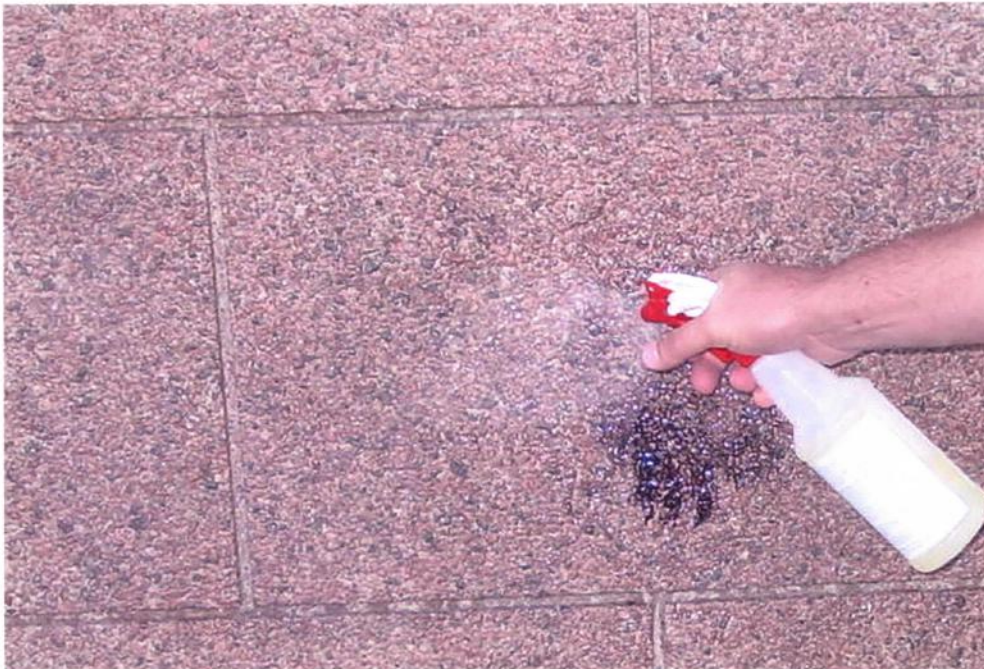
16. Applied graffiti being removed with Erasol.

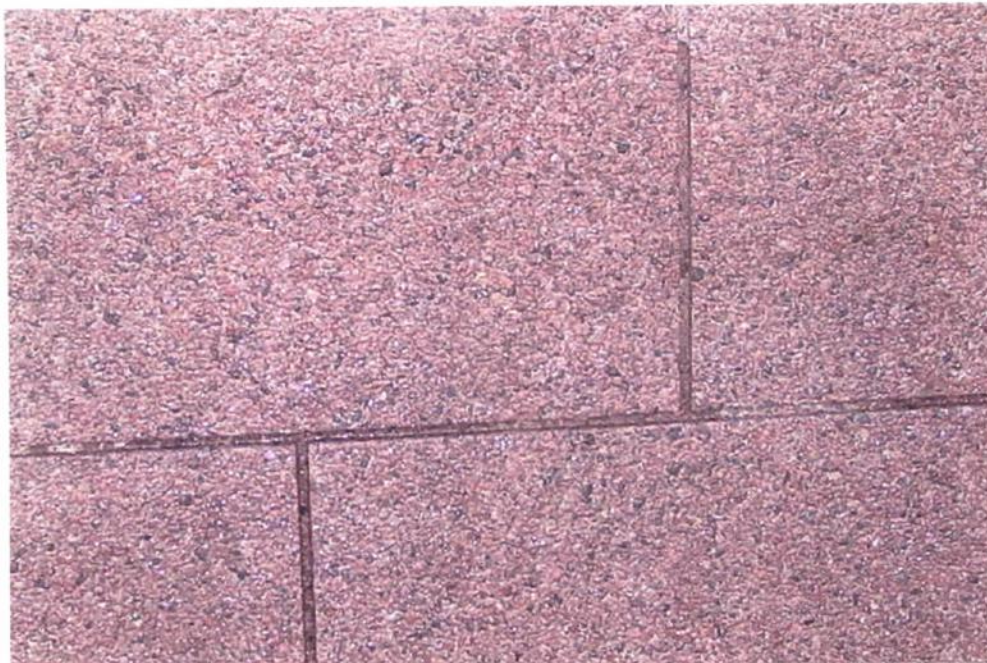
17. Surface after graffiti removal.

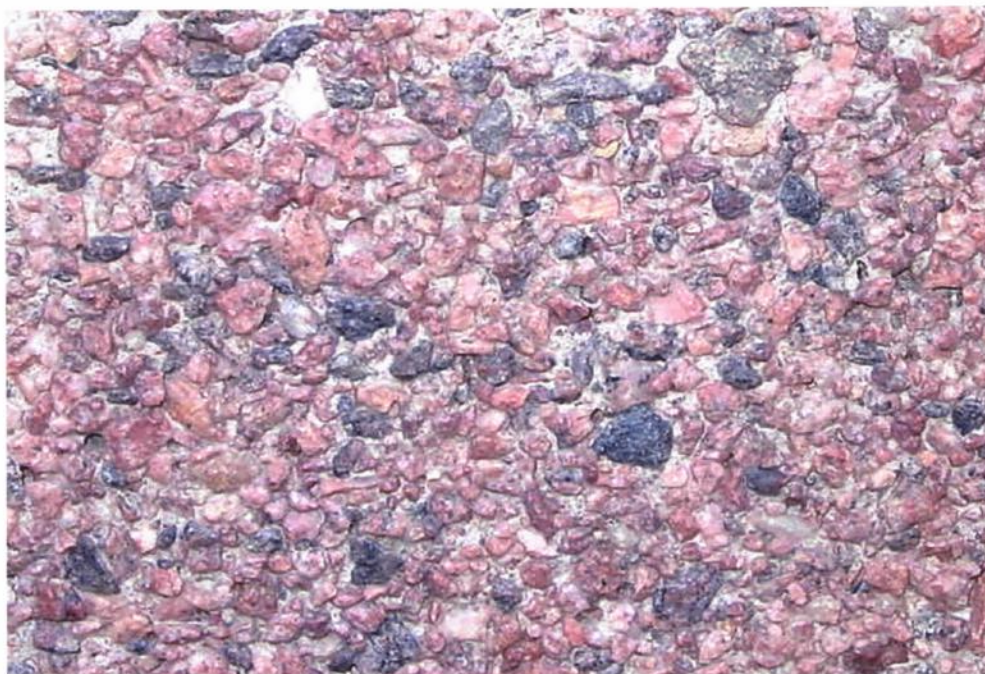
18. Close-up of surface after removal. Note the total lack of any black staining.

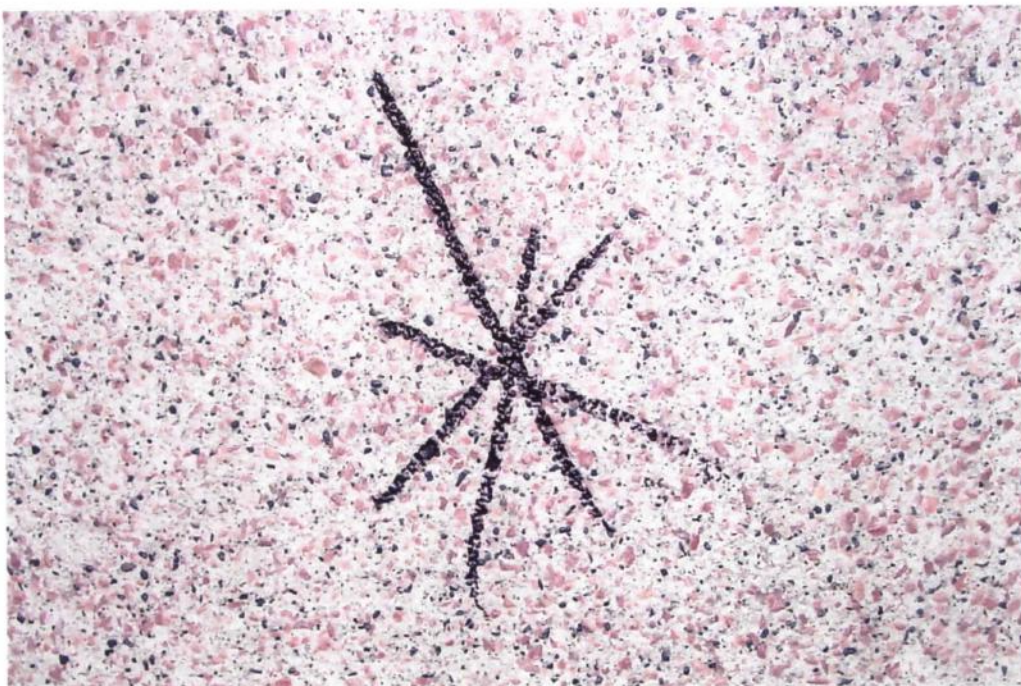
20. Surface with applied graffiti.

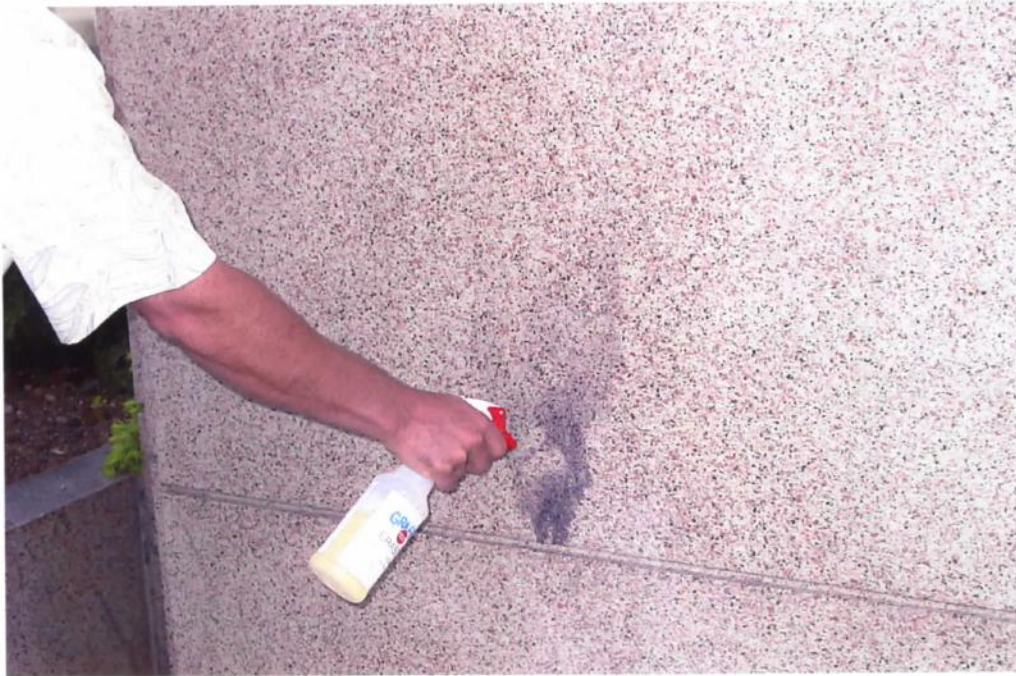
21. Applied graffiti being removed with Erasol.

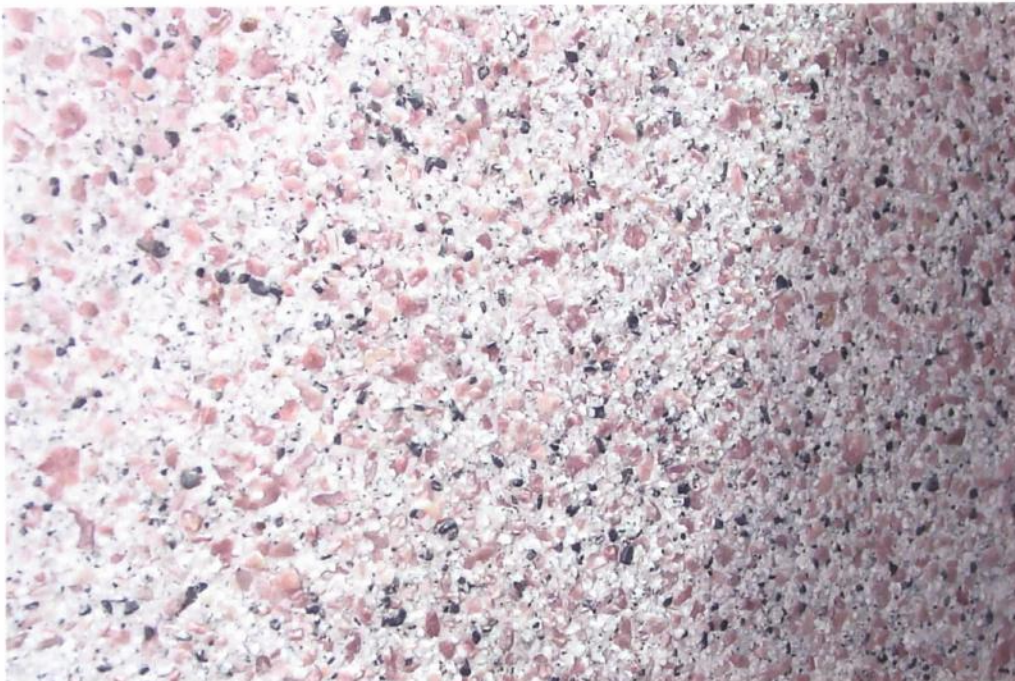
22. Close-up of surface after removal. Note the total lack of any black staining.

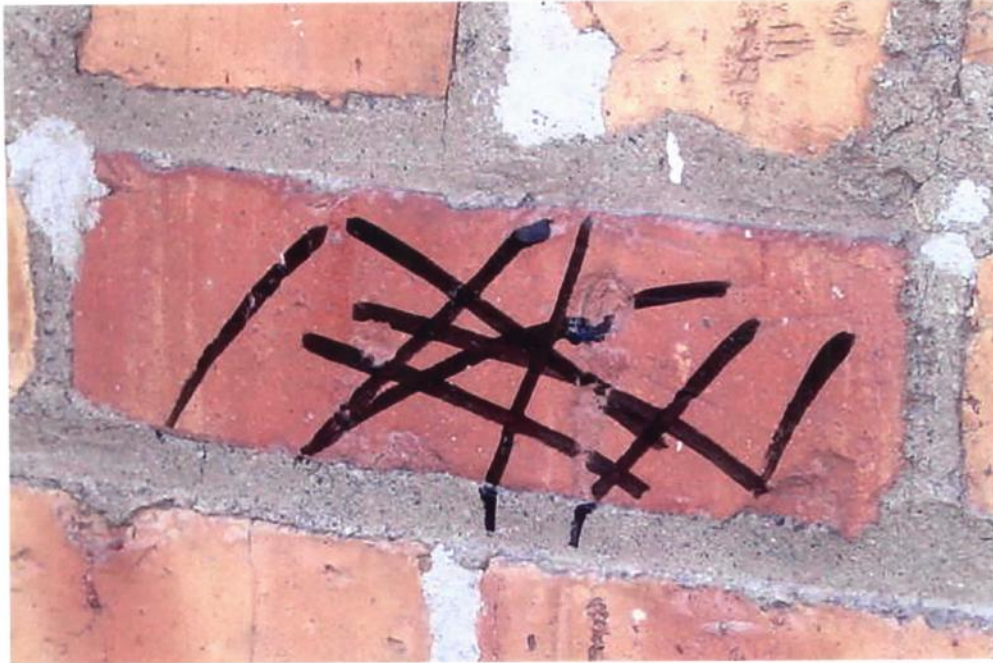
23. Surface with applied graffiti.

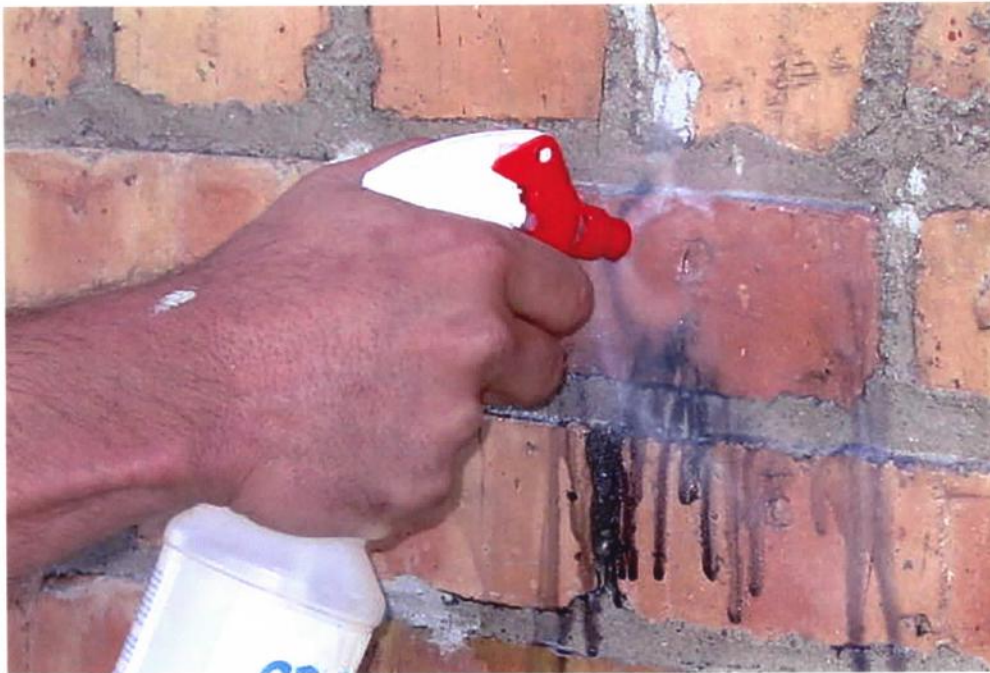
24. Applied graffiti being removed with Erasol.

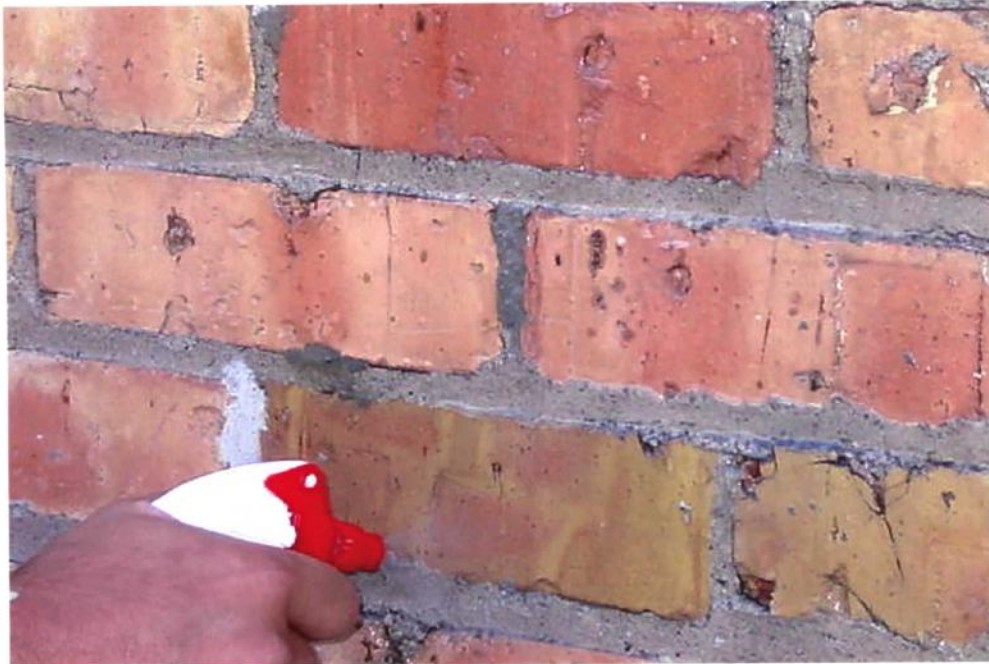
25. Erasol being flushed with water

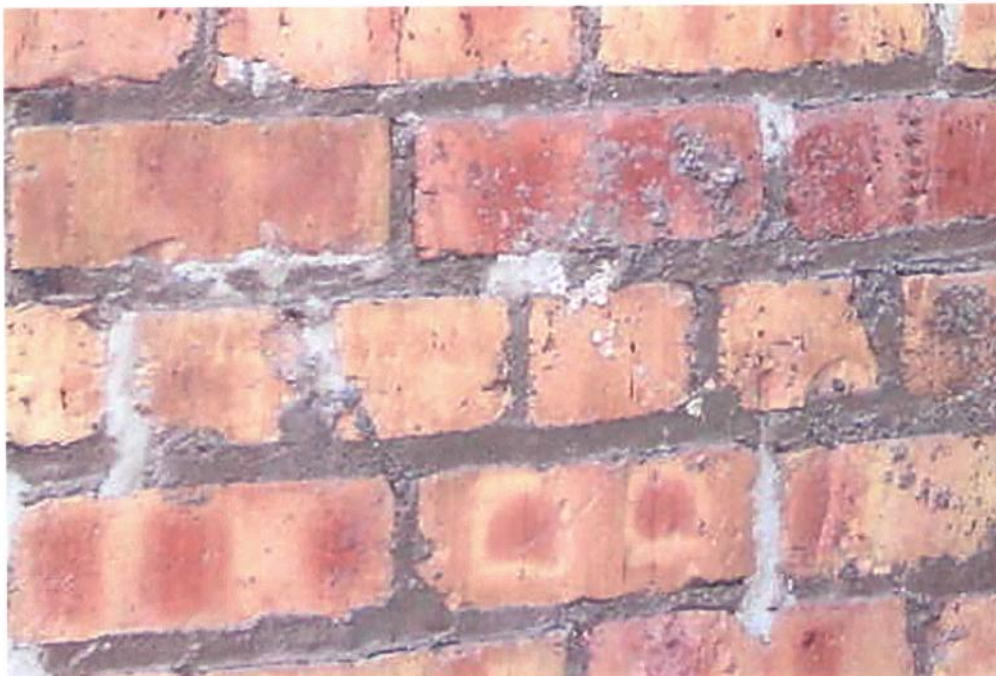
26. Close-up of surface after removal. Note the total lack of any black staining.

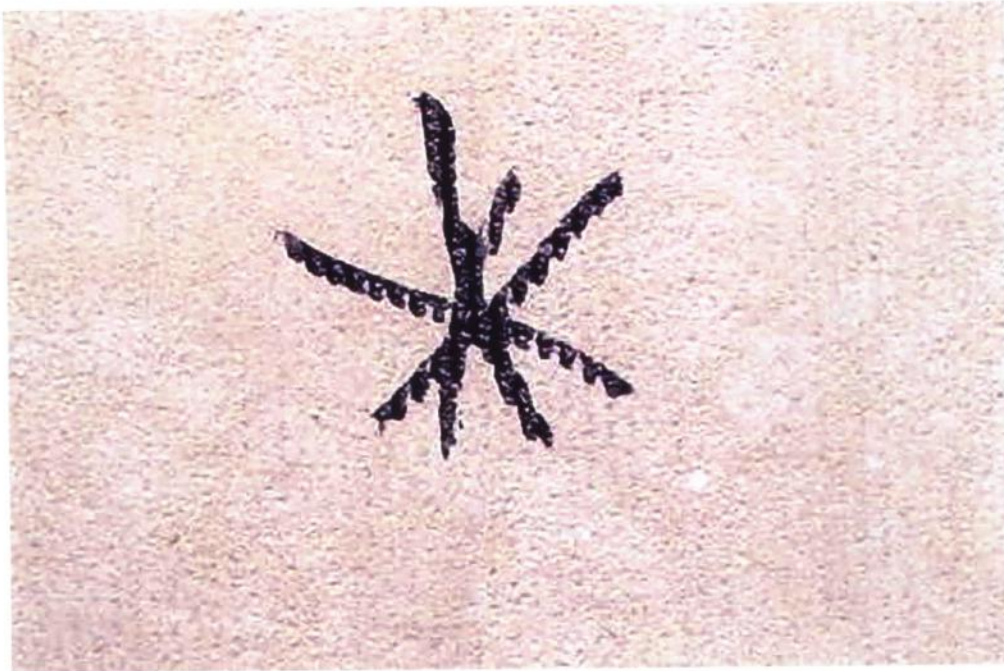
27. Surface with applied graffiti.

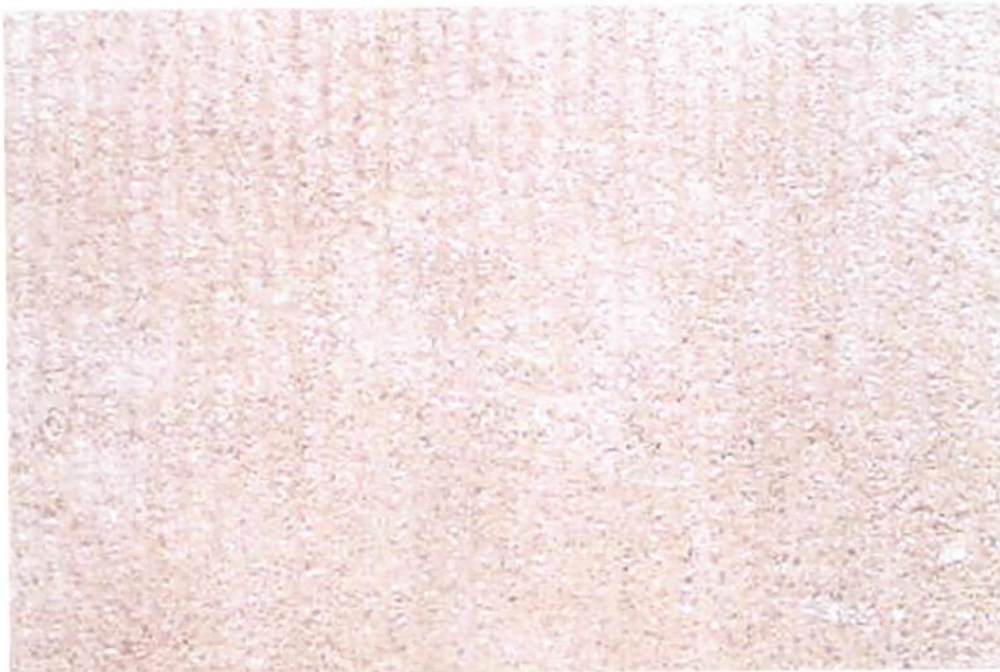
28. Close-up of surface after removal. Note the total lack of any black staining.

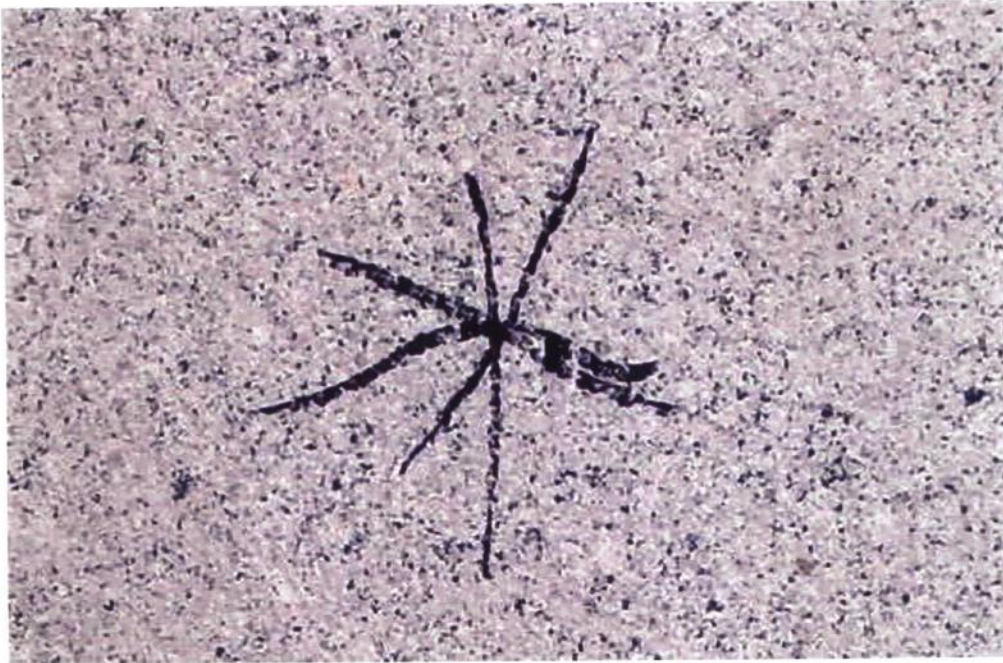
29. Surface with applied graffiti.

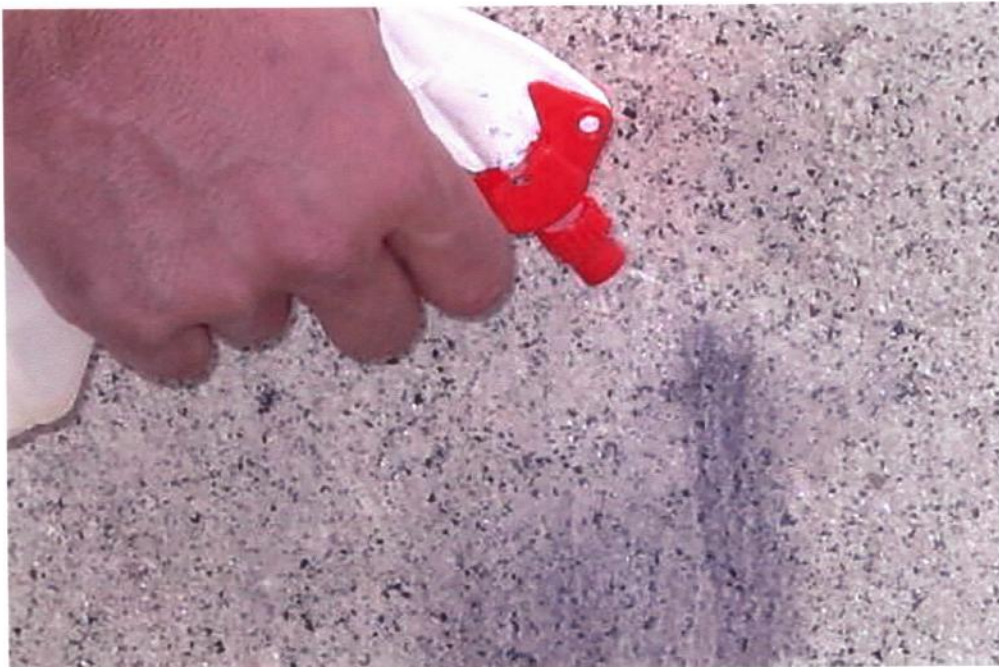
30. Applied graffiti being removed with Erasol.

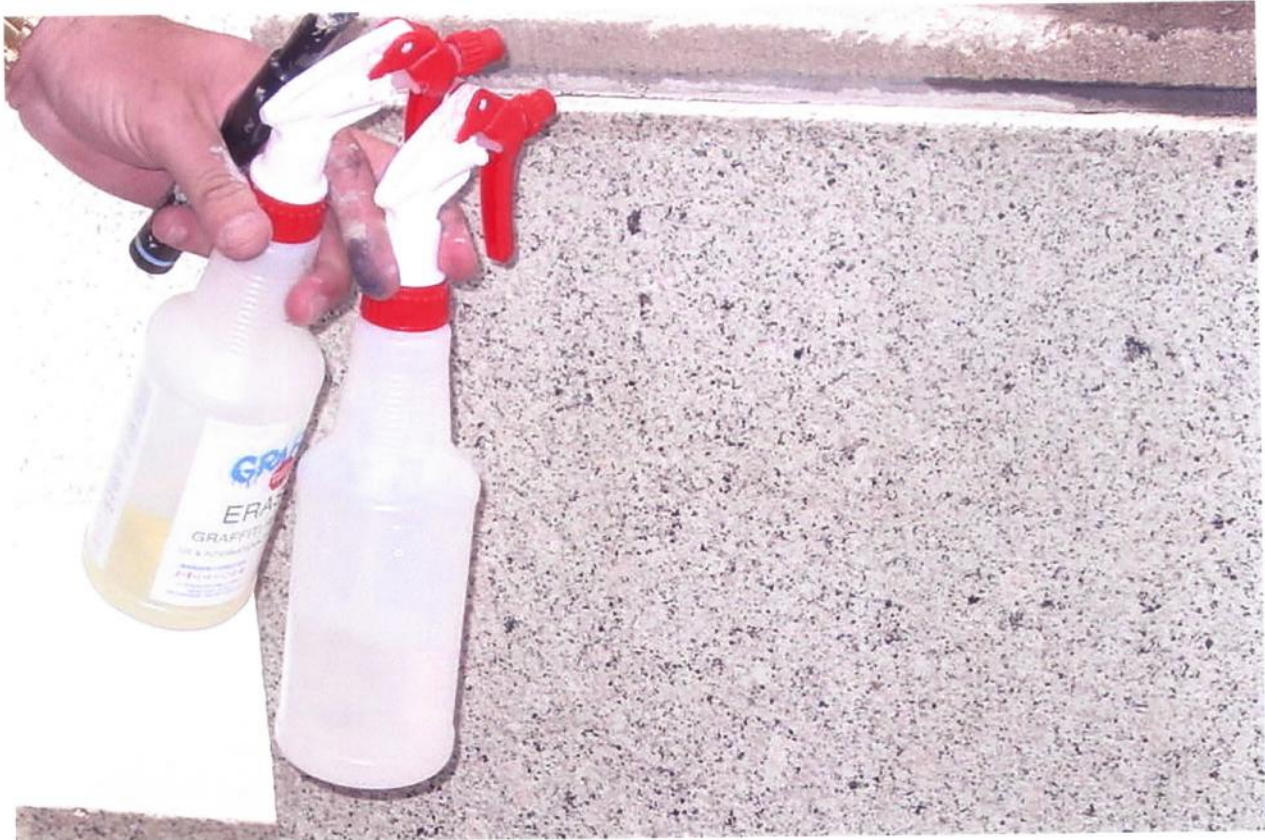
31. Close-up of surface after removal. Note the total lack of any black staining.

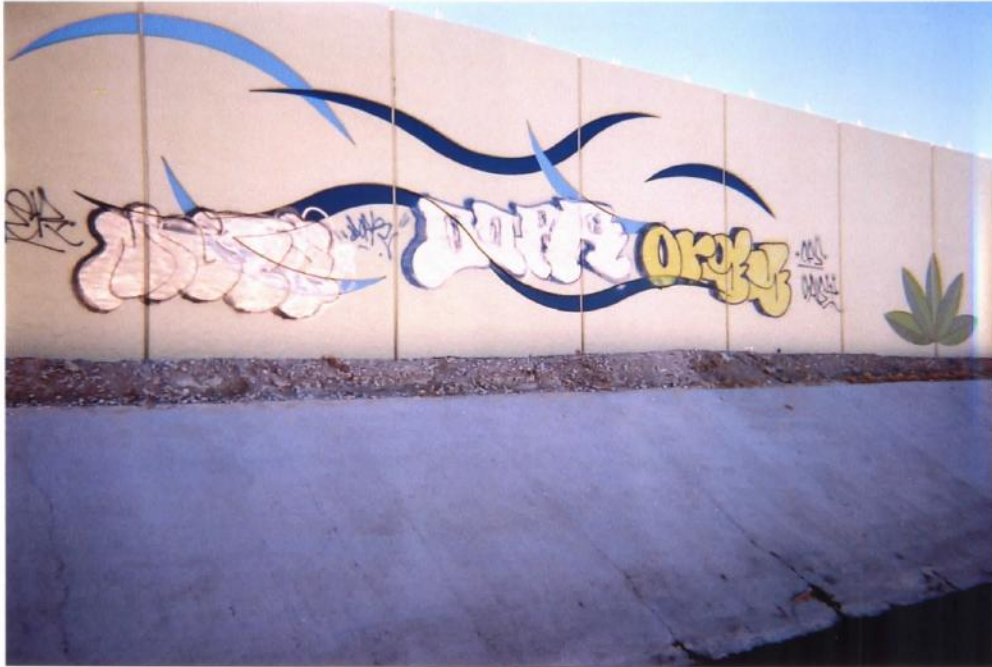
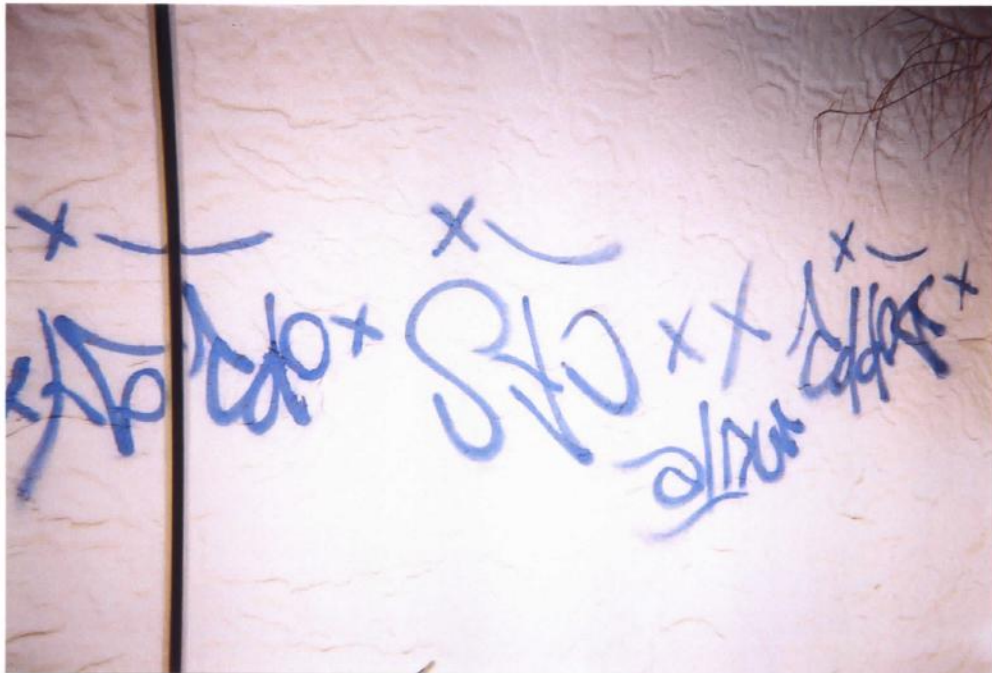
HIGHWAY 95 SOUND WALL TAGGED WITH GRAFFITI

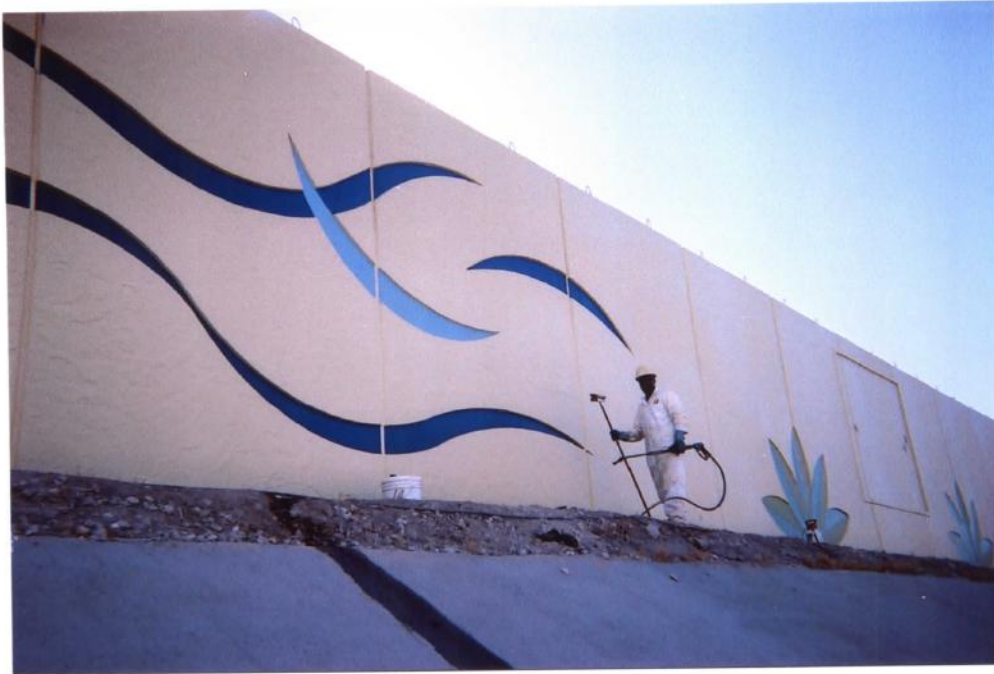
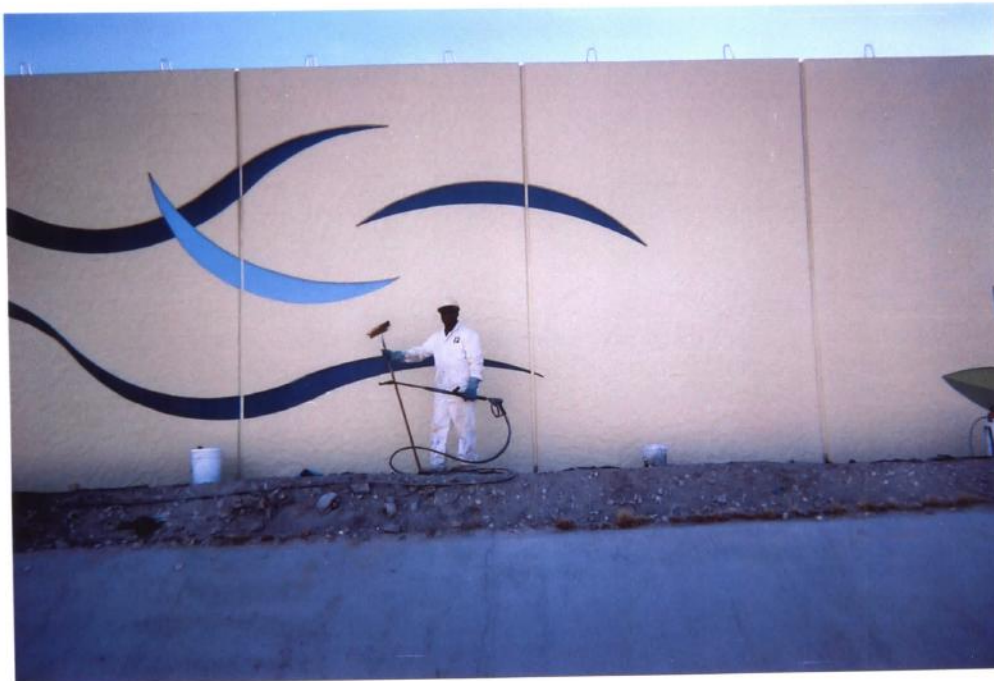
HIGHWAY 95 SOUND WALL AFTER GRAFFITI REMOVAL
