MPI's Test: LocoMoto Clear Coat

Test to Prove Effectiveness of Coating 27 SEPT 2012

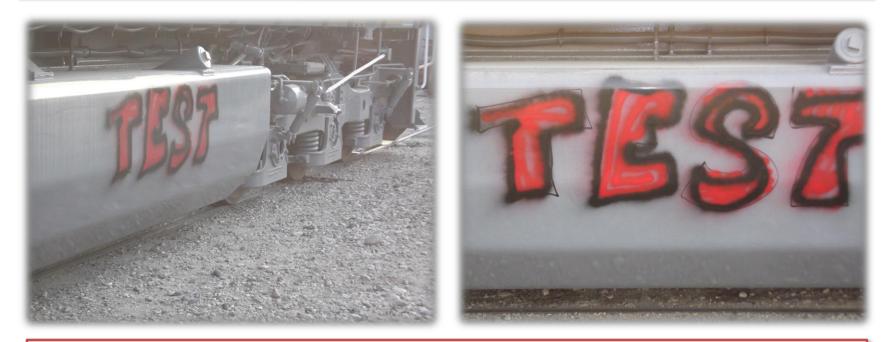
Test paint used for tagging locomotive fuel tank

- •≈1/4 can of Rustoleum[®] Red
- •≈1/8 can of Rustoleum[®] Black

• Sharpie[®] black permanent marker for an outline Date test paint applied: 9/12/12

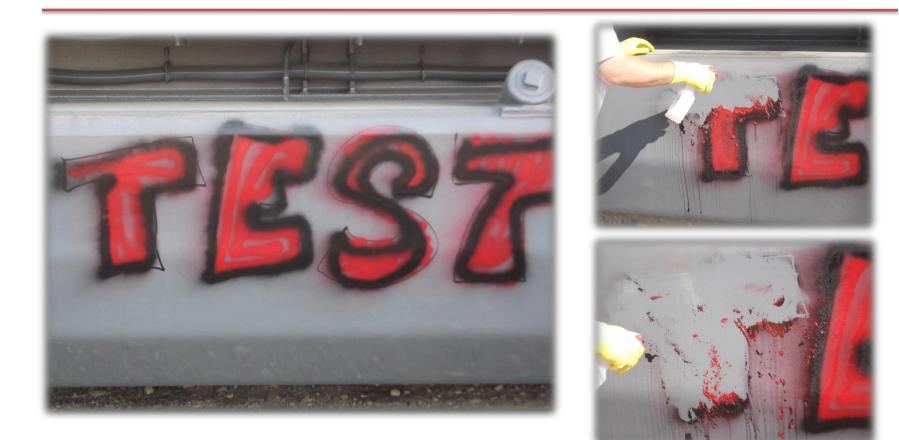
Date of Removal: 9/27/12 (paint set for 15 days) Medium used for paint removal: Erasol™ Quantity of remover used in test: 39 oz Price of Erasol™: \$9.95/pint (total cost for test media removal = \$24.25)

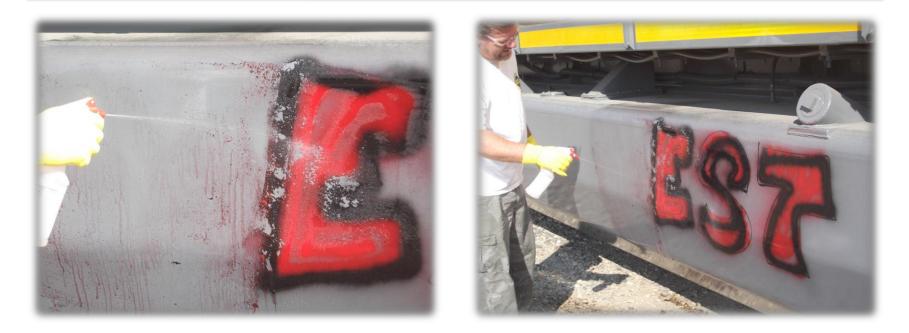
Temperature at Time of Removal: 72°

Steps to Removal:

- 1. Spray affected area with Erasol[™] Graffiti Remover
- 2. Allow Erasol[™] time to penetrate paint
- 3. Lightly scrub thickest area of paint with soft, nylon brush
- 4. Rinse area with clean tap water
- 5. Wipe area with clean rag or cloth

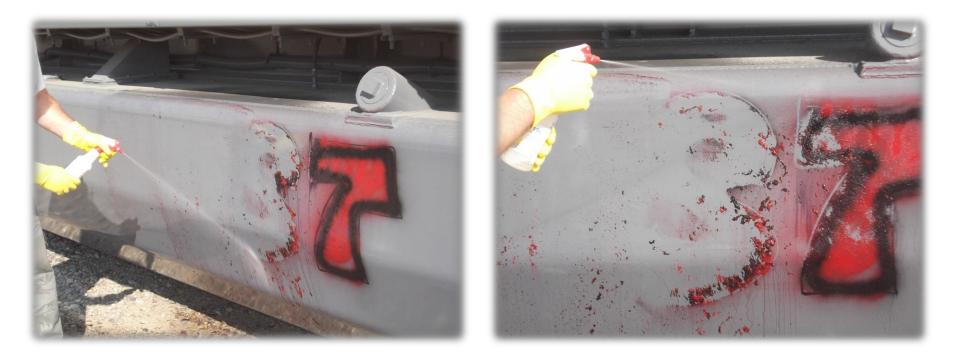
Notice the outline of the tagged area where the Sharpie[®] had outlined the lettering.

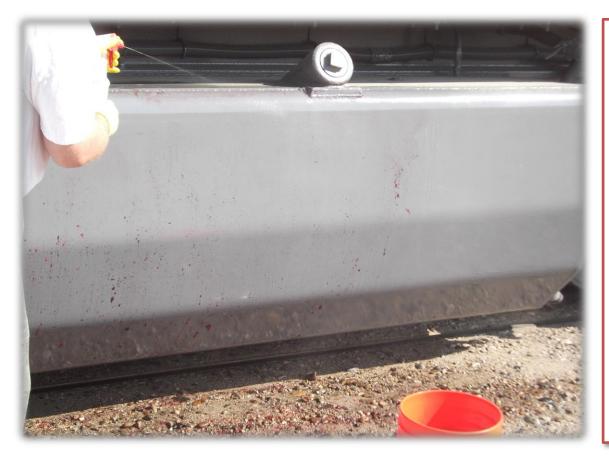
Final spray down with Erasol[™] on the LocoMoto Clear Coat prior to rinsing with water from the tap.

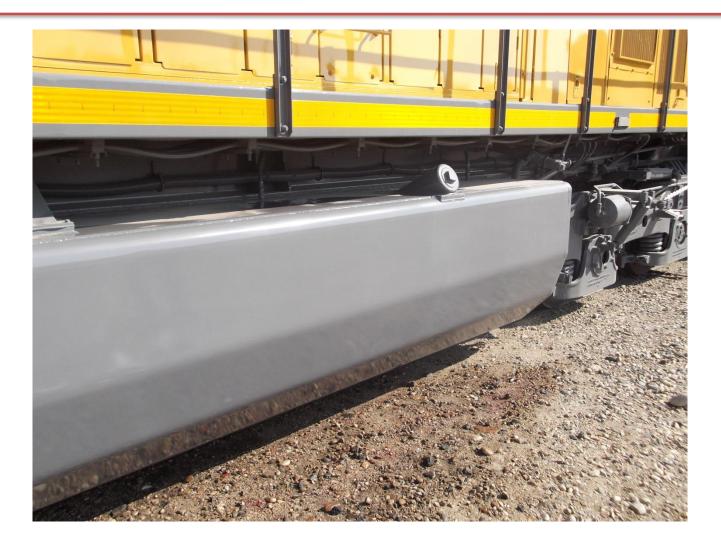
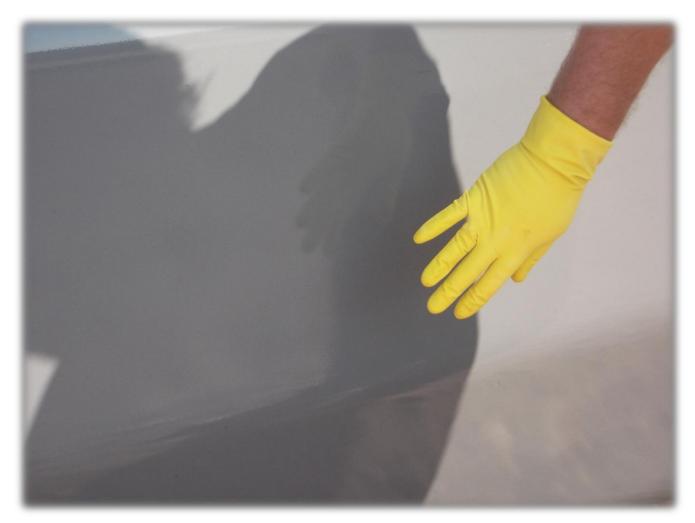
Notice the reflection of the glove in the coating. The finish is as shiny as day of tagging. The cleaning agent removed the graffiti from the paint, but did not damage the finish.

Total time to remove graffiti: 15mins 37 secs.
